## **Executive Summary of Crash Test Report 1970 Ford F-100 Pickup Truck & 1999 Ford Crown Victoria Police Interceptor**

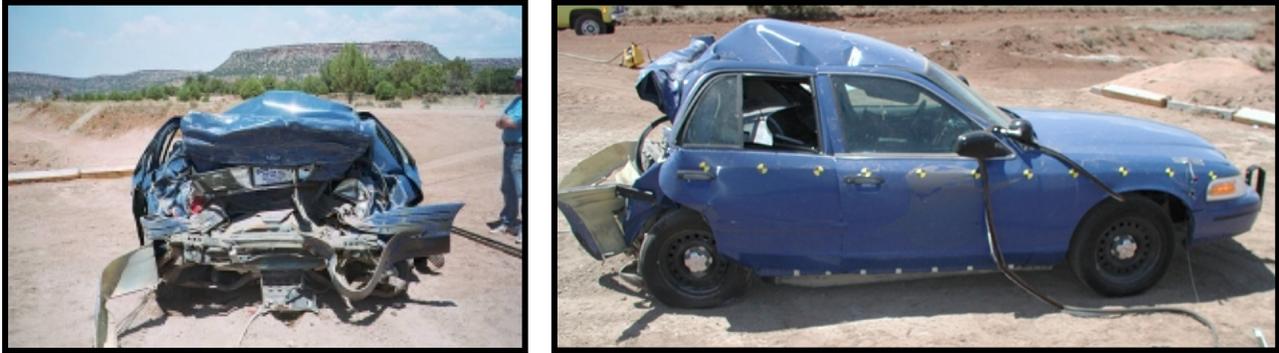
impact moved the FCVPI 79.4 feet down the track, with the FCVPI coming to rest at TS 1855.4 (see Figure 3). The sled with the pickup truck came to rest at TS 1911. The HMTT Safety Officer declared the site safe to inspect in a matter of minutes.

**Figure 3** Ford Crown Victoria Police Interceptor post-crash

The impact of the pickup truck into the FCVPI caused substantial damage to the FCVPI. However, there was no fire. Fuel leakage was minimal and only at the point of rest and had stopped within minutes of the impact.

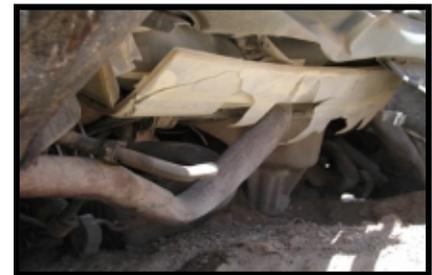
In observing the high-speed video footage of the test, one can see a cloud of powder emanating from the rear portion of the FCVPI. This is the powder being released from the FIRE Panels as they are shattered by the crushing of the FCVPI (see Figure 4). The amount of powder in the proximity of the fuel tank and potential ignition sources explains why any potential leaking fuel would not catch fire. The powder lingers in the proximity of the FCVPI for a reasonable period of time after the FCVPI stops moving from impact. Inspection at the site of the FIRE Panels shows that they fractured as expected and released the majority of their contents. Had the vehicle traveled even farther after impact, additional powder was present to add to the “cloud”.

**Figure 4** FIRE Panel post-crash
