Executive Summary of Crash Test Report:

1993 Ford Taurus Into 1998 Ford Crown Victoria Police Interceptor and 1994 Ford Taurus Into 1999 Ford Crown Victoria Police Interceptor

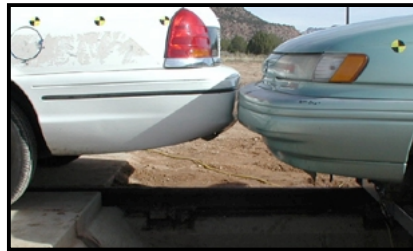
Two CVPIs were prepared for the tests using identical protocols. In each test, a Ford Taurus was crashed into a standard, late model Ford CVPI at a high rate of speed. The Taurus made contact with the CVPI, centerline bumper to centerline bumper, at a 50% offset (35.3 inches) (see **Images 3 & 4**). Each CVPI had its fuel tank filled to 95% capacity (18.05 gallons) with regular-grade unleaded gasoline. To guarantee that the fuel tank would be punctured during the crash, a metal device with several points was welded to the rear driver's side axle with the points facing the fuel tank. The Taurus has its headlights on, as there is evidence that the hot filament in the headlight of a vehicle that hits the CVPI might be a potential ignition source. The CVPI had been driven into place, turned off, and then re-started 10 minutes prior to impact, hence the engine and exhaust components were at normal operating temperatures. At impact, the CVPI had its warm engine running and its transmission in "Park".

Image 3 – Bumper to bumper

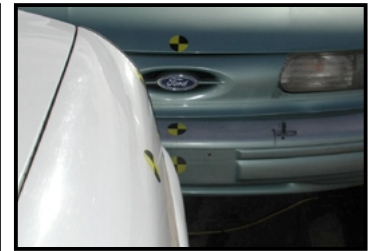
Image 4 – 50% offset
