Executive Summary of Crash Test Report:

1993 Ford Taurus Into 1998 Ford Crown Victoria Police Interceptor and 1994 Ford Taurus Into 1999 Ford Crown Victoria Police Interceptor

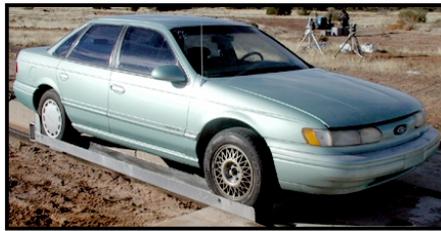
Image 1 – Ford Taurus on sled

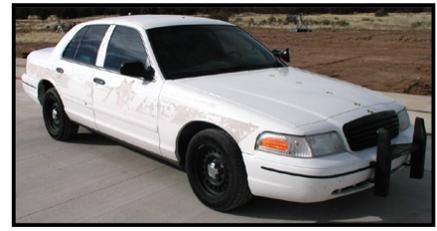
Image 2 – Crown Victoria Police Interceptor

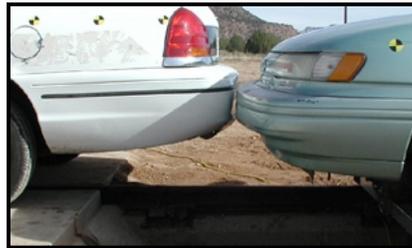
Two CVPIs were prepared for the tests using identical protocols. In each test, a Ford Taurus was crashed into a standard, late model Ford CVPI at a high rate of speed. The Taurus made contact with the CVPI, centerline bumper to centerline bumper, at a 50% offset (35.3 inches) (see **Images 3 & 4**). Each CVPI had its fuel tank filled to 95% capacity (18.05 gallons) with regular-grade unleaded gasoline. To guarantee that the fuel tank would be punctured during the crash, a metal device with several points was welded to the rear driver's side axle with the points facing the fuel tank. The Taurus has its headlights on, as there is evidence that the hot filament in the headlight of a vehicle that hits the CVPI might be a potential ignition source. The CVPI had been driven into place, turned off, and then re-started 10 minutes prior to impact, hence the engine and exhaust components were at normal operating temperatures. At impact, the CVPI had its warm engine running and its transmission in "Park".

Image 3 – Bumper to bumper

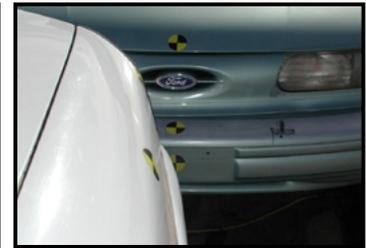
Image 4 – 50% offset
